REPAIRING SKIRTING BOARDS

In this case study, Darryl Evans (Heritage Carpenter and Joiner) describes how he repairs and replicates skirting boards at the Port Arthur Historic Site.

Darryl is carrying out scheduled conservation work (including skirting board repairs) on the entry portico of the Commandant's House.

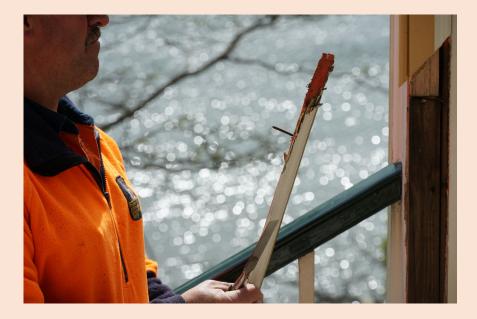
Darryl at the Commandant's House
